UNDERWATER BRIDGE INSPECTION REPORT

STRUCTURE NO. 7183

ST. LOUIS RIVER

MINNESOTA DEPARTMENT OF TRANSPORTATION
UNDERWATER BRIDGE INSPECTION

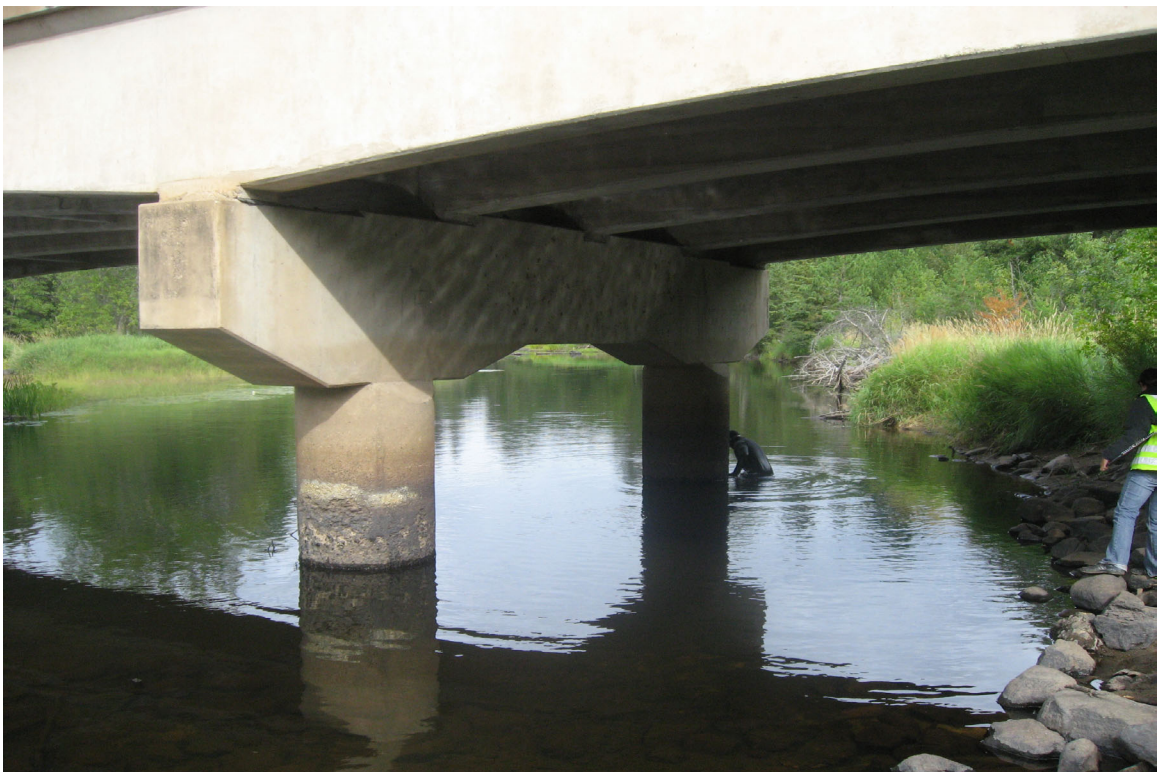
Photograph 2. View of Pier 1, Looking Northeast.

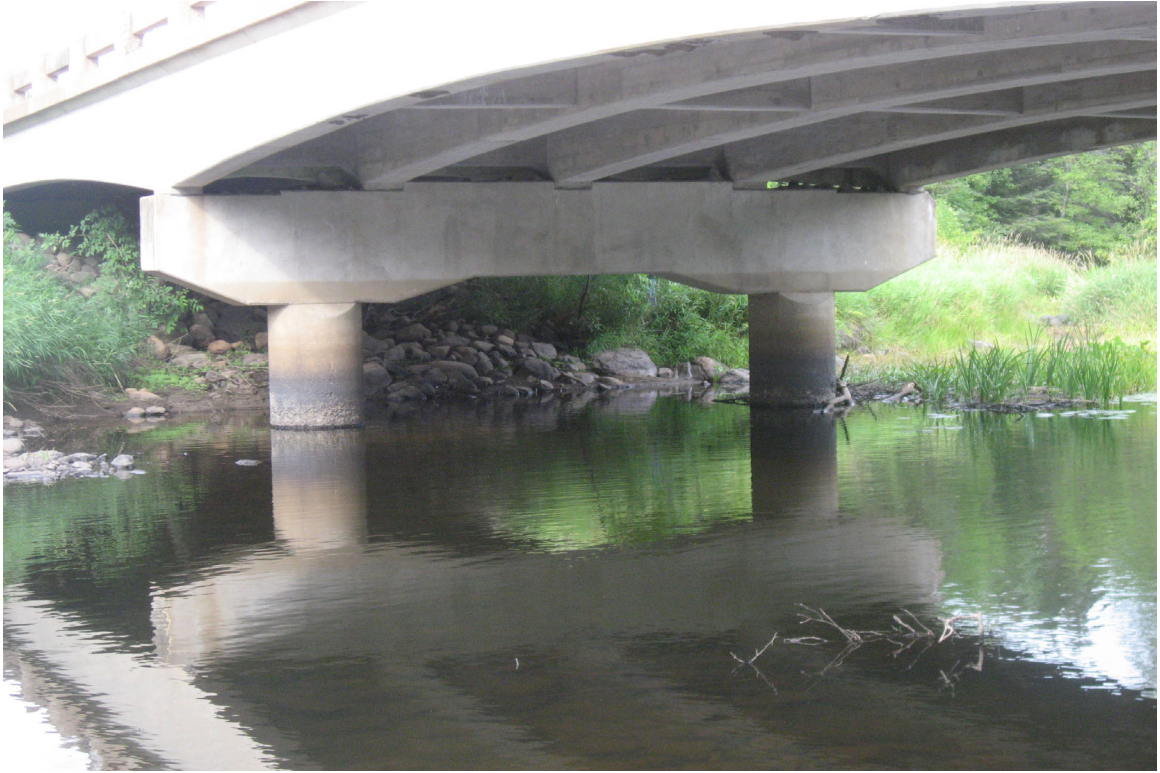
Photograph 3. View of Pier 2, Looking Northeast.

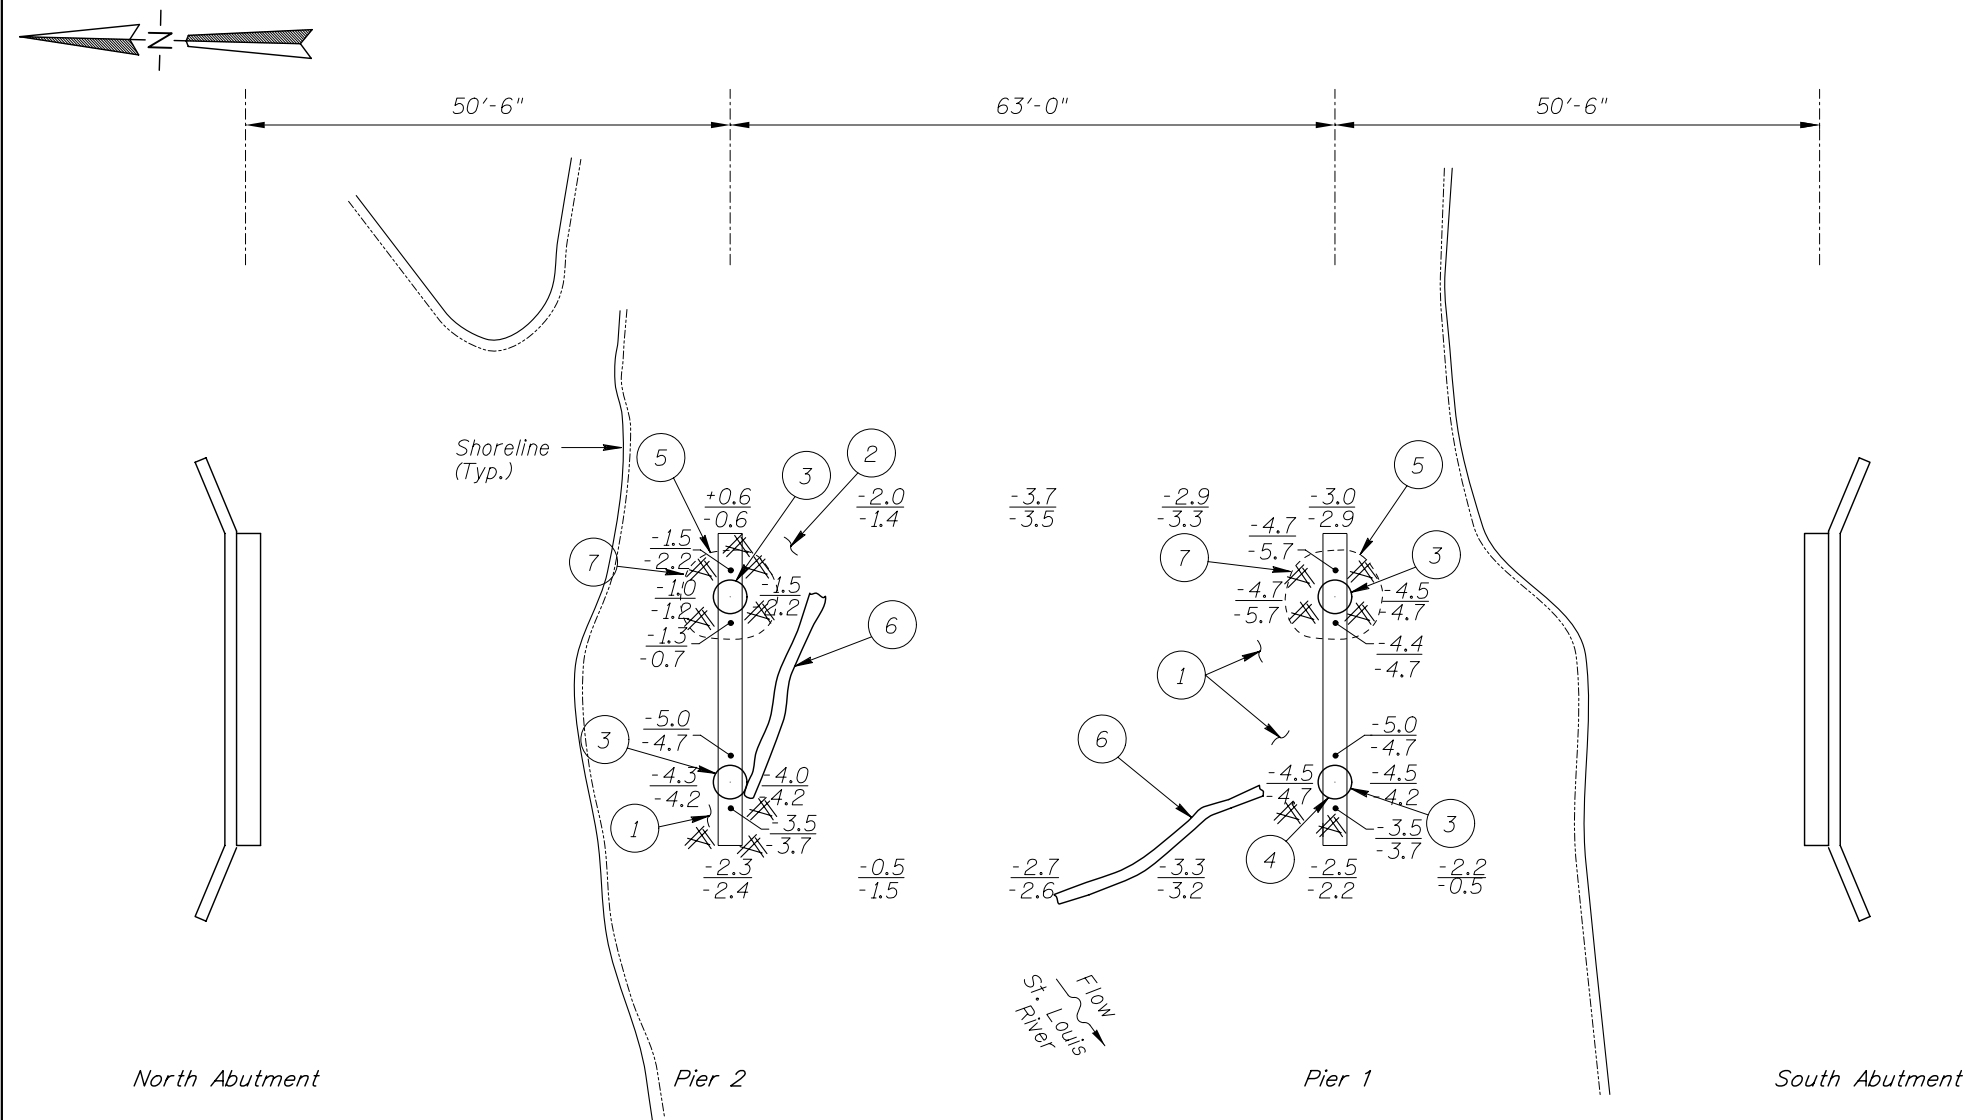
INSPECTION AND SOUNDING PLAN

- 1 The channel bottom consisted of sand and gravel with 6-inch-diameter and smaller cobbles and random 1-foot-diameter riprap and a maximum probe rod penetration of 1 inch.

- 2 The channel bottom consisted of soft silt and organic material with 1.5 feet of probe rod penetration at the upstream column of Pier 2.
- 3 Light to moderate scaling with some aggregate exposure from 4 feet above the waterline to 1.5 feet below the waterline with typical penetrations of 1/8 inch and up to 1/4 inch maximum at the upstream columns. Heavier scaling was observed at the downstream columns with a maximum penetration of 1.5 inch at Pier 1 & 2.

- 4 An area of heavy scaling/section loss was observed around the downstream column of Pier 1, 2-foot-high by 2.5-feet-wide at 1 foot below the waterline with a maximum penetration of 1 inch.

- 5 A scour depression, 3 feet in radius with a depth of 2 feet, was observed at the upstream columns of Pier 1 & 2. The accumulation of timber debris was observed in the depression.

- 6 6-to 12-inch-diameter log was observed from the channel bottom to the waterline along Pier 1 & 2 as shown.
- 7 A light to moderate accumulation of 6-inch-diameter and smaller timber debris was at the upstream and downstream ends of Pier 1 & 2. Accumulations extended from the channel bottom up 3 feet.
